LABORATORY EVALUATION OF A SHIPBOARD MULTIFUNCTIONAL WASTE INCI--ETC(U)  
OCT 79 F CROWSON, J A BYRNE, W W JONES

NSWC/TR-79-264

4. TITLE (and Subtitle) LABORATORY EVALUATION OF A SHIPBOARD MULTIFUNCTIONAL WASTE INCINERATOR (MFI). PHASE II	5. TYPE OF REPORT & PERIOD COVERED Final rept.	6. PERFORMING ORG. REPORT NUMBER

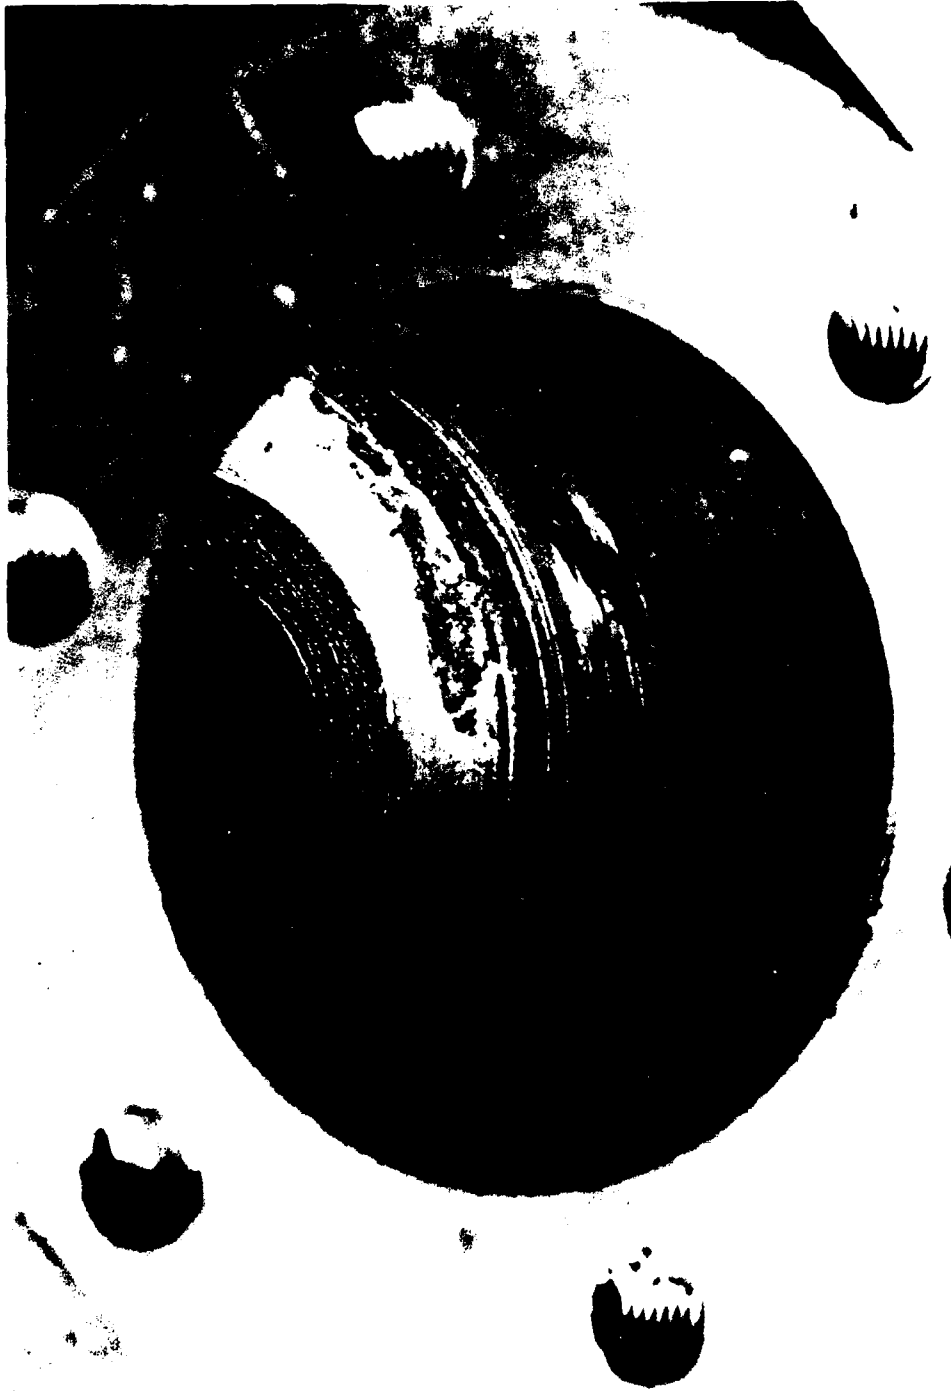
Certain problems with equipment necessary for the operation of the MFI-II, but not considered part of the system during the evaluation, are discussed here to be documented while encountered throughout the testing. As mentioned under Failures, problems were encountered with the fuel-oil system because of inadequate in-line filters/strainers. After approximately 380 hr of operation, the circulating oil pump showed indication of reduced output pressures. Disassembly showed damage (0.001- to 0.002-in. grooves) to the impeller and internal wear of the pump body (Figure 8). Replacement was made with a new pump; however, approximately 308 hr later the new pump failed and required replacement. The pump manufacturer was consulted, and the original belt drive operation was replaced by direct drive operation. Fine felt filters were installed upstream of the pump to ensure proper filtration of No. 2 fuel oil. No further wear on the pump was experienced after making these modifications.

Figure 8. Wear on the Fuel-Oil Pump Body After 380-hr Operation

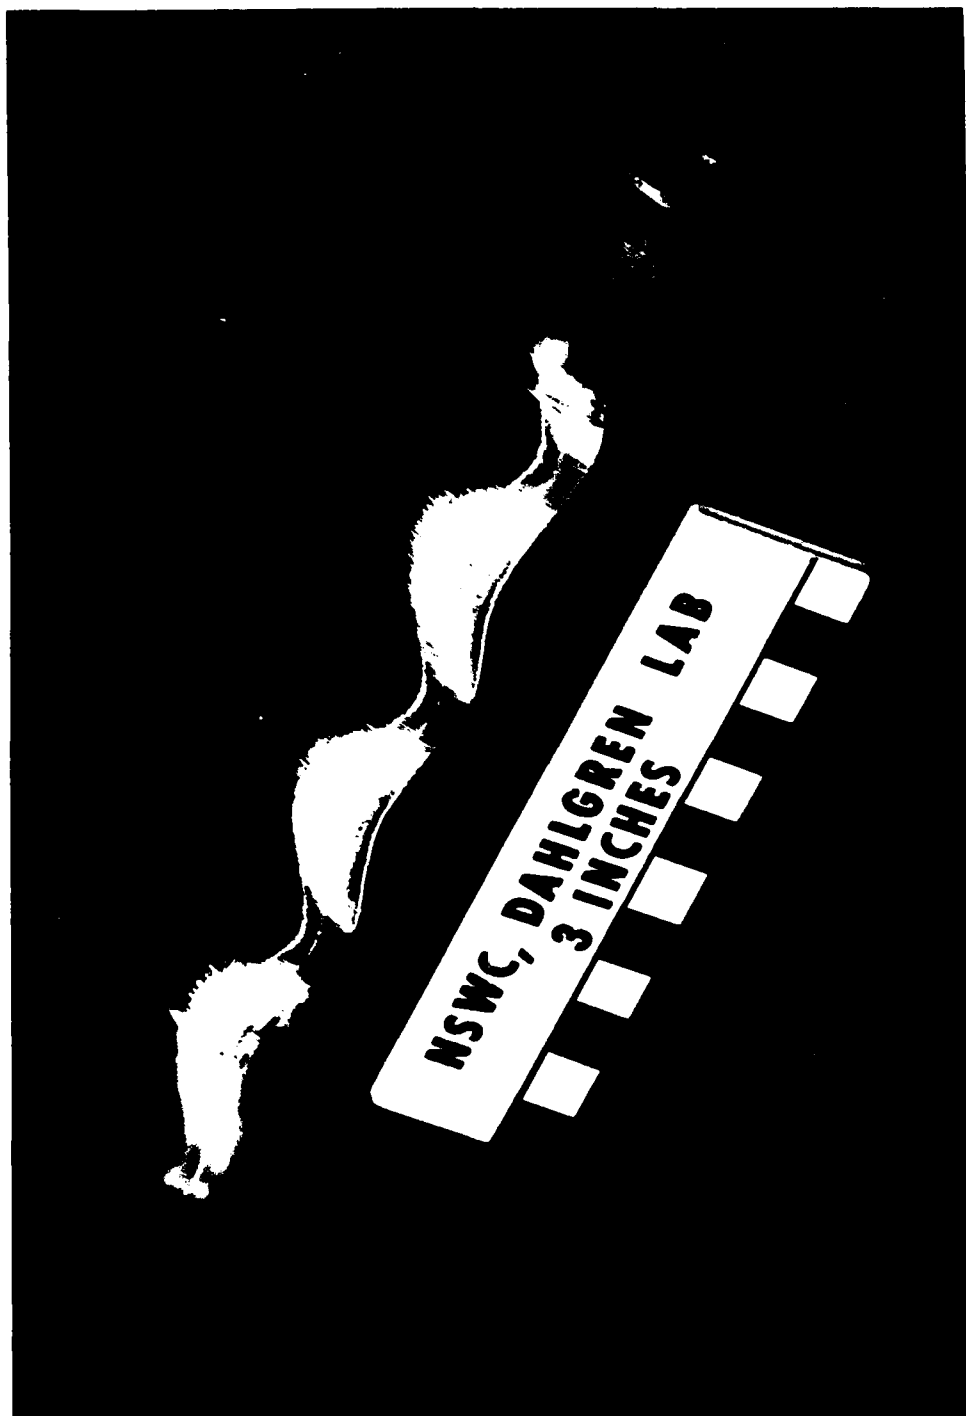
After approximately 540 hr of operation, sewage flow rates were observed to decrease by 30 percent. Disassembly of the sewage delivery pump showed wear to the stator and rotor (Figures 9 and 10). Failure occurred after the 10 tests (82 hr) with saltwater sewage. Replacement was made with a new pump, and no further problems occurred after returning to freshwater sewage.

Figure 9. Worn Stator of Sewage Pump

Figure 10. Worn Rotor of Sewage Pump

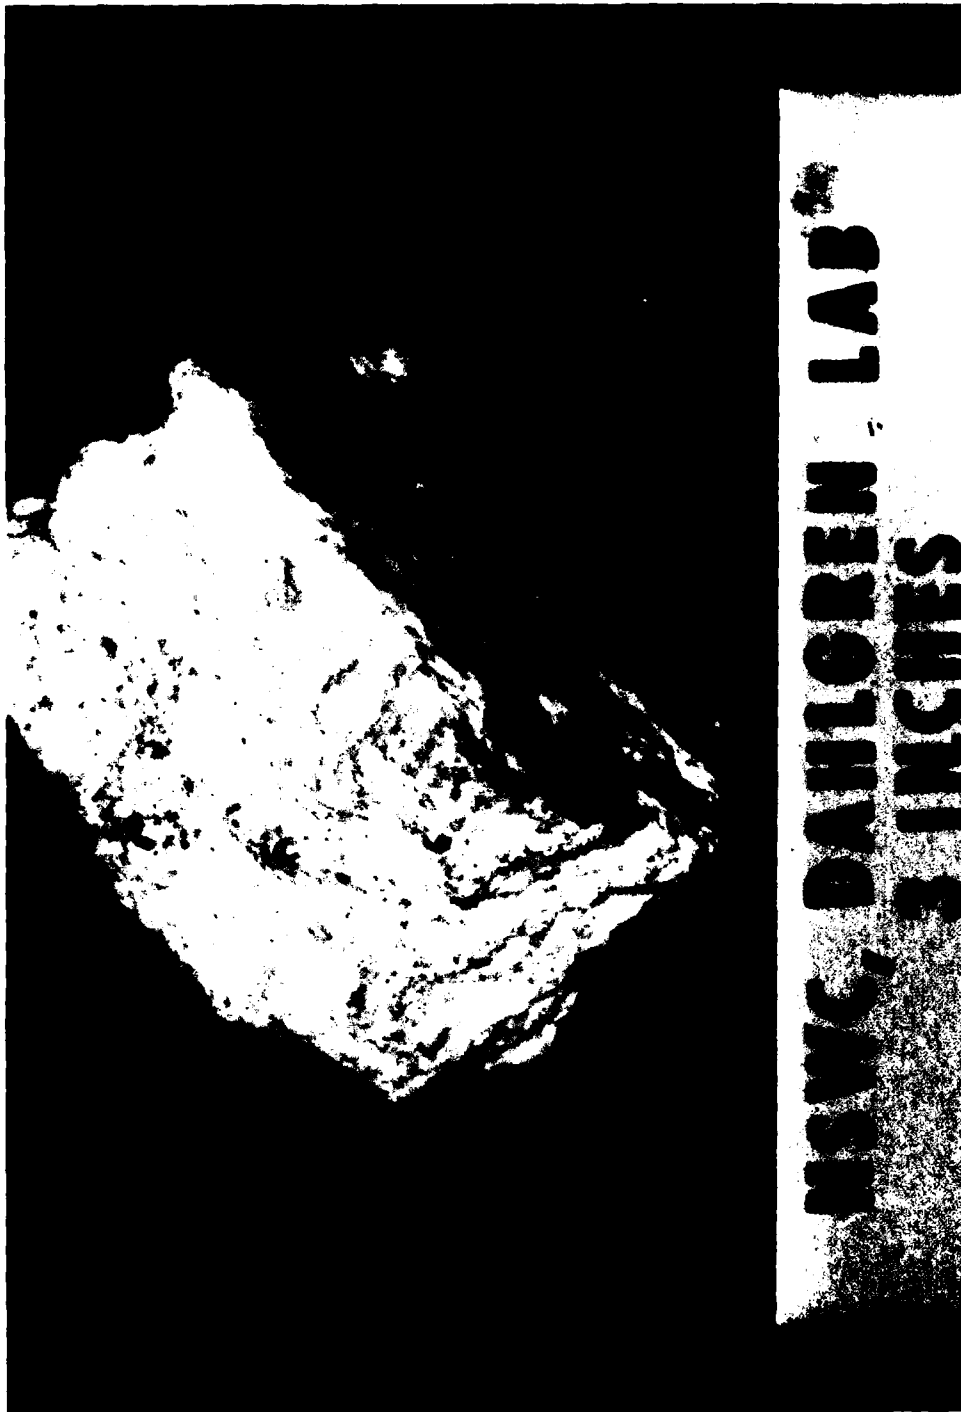
Figure 23. Refractory Chunk From Flame Impingement Wall

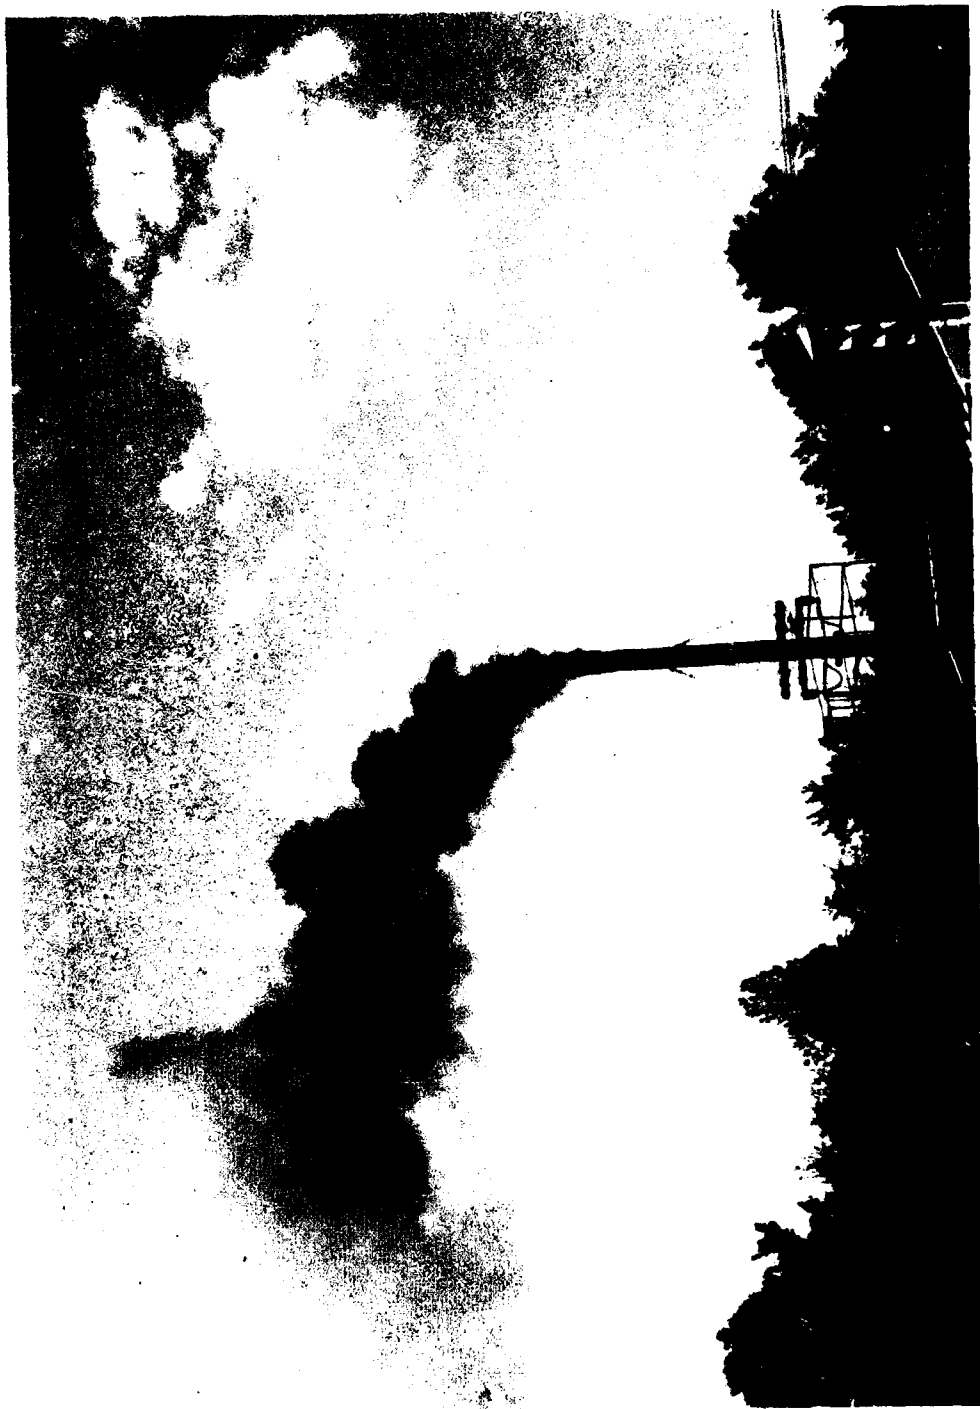
Trained-observer readings during freshwater SETs indicated opacity in excess of the 20-percent design requirement. Figure 27 represents the smoke plume for 1 min of stoking, and similar plumes were obtained when feeding high-plastic-content wastes. Figure 28 shows the stack under normal burning conditions with the fuel burner properly adjusted. Emission problems due to the burning of various fuels will be solved by efficient burner designs or specification of a particular burner setting for individual applications. A subjective evaluation was made by personnel from NAVSEC, NSWC, and a Naval Sea Systems Command (NAVSEA) consultant on stack gas odor during refuse and sewage burns. Figure 29 shows personnel at stack height during feeding operation. Consensus of the individuals involved was that no objectionable odors were discernible at any time during testing.

Figure 27. Stack Emissions During Stoking and Feeding of High-Plastic-Content Wastes
